North Dakota Transmission
Authority

Overhead to Underground

City of Lakota/Lakota Municipal Utilities

Summary of MRES Assessment for Lakota Distribution System

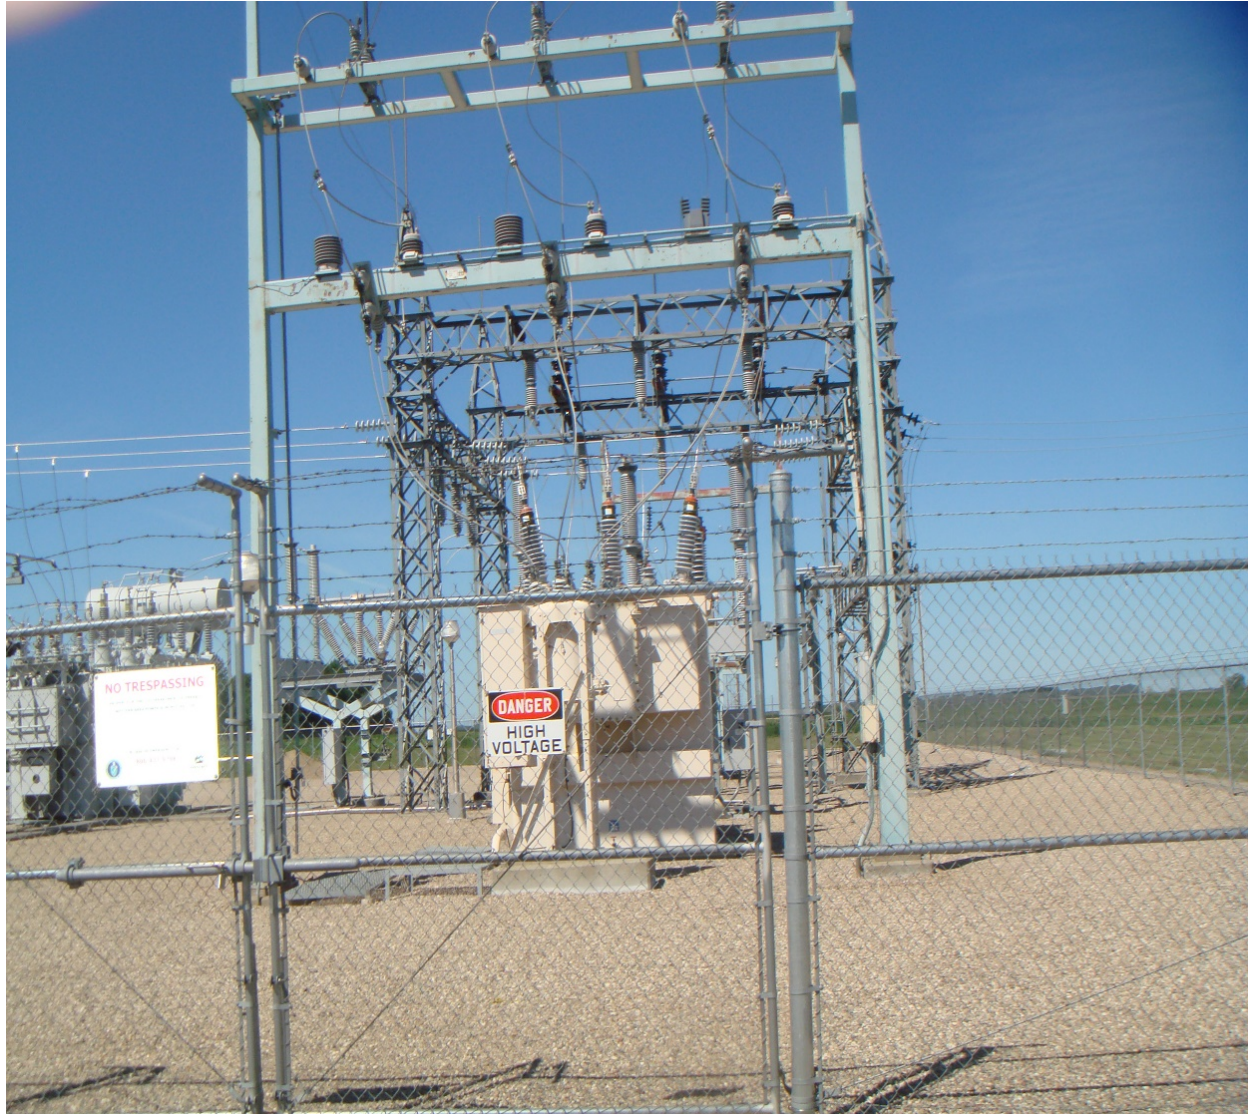
WAPA/Lakota Main Sub

- The upgrades planned by WAPA for the substation will be a great upgrade.
- At this same time, Lakota should consider making repairs and replacements on existing alternate feed.
- Community should also consider adding a second feeder from the normal feed into the community to help limit some risk.
- More discussion on this later.

- b. Primary distribution source into the community – Lakota should look at a second feeder into the community to help limit some of its potential exposure. MRES considers this a *Priority*.

- b. Primary distribution source into the community – *Priority* – Lakota should look to engage a distribution engineering firm to evaluate this in conjunction with evaluation of the 7200/2400 distribution substation in town.

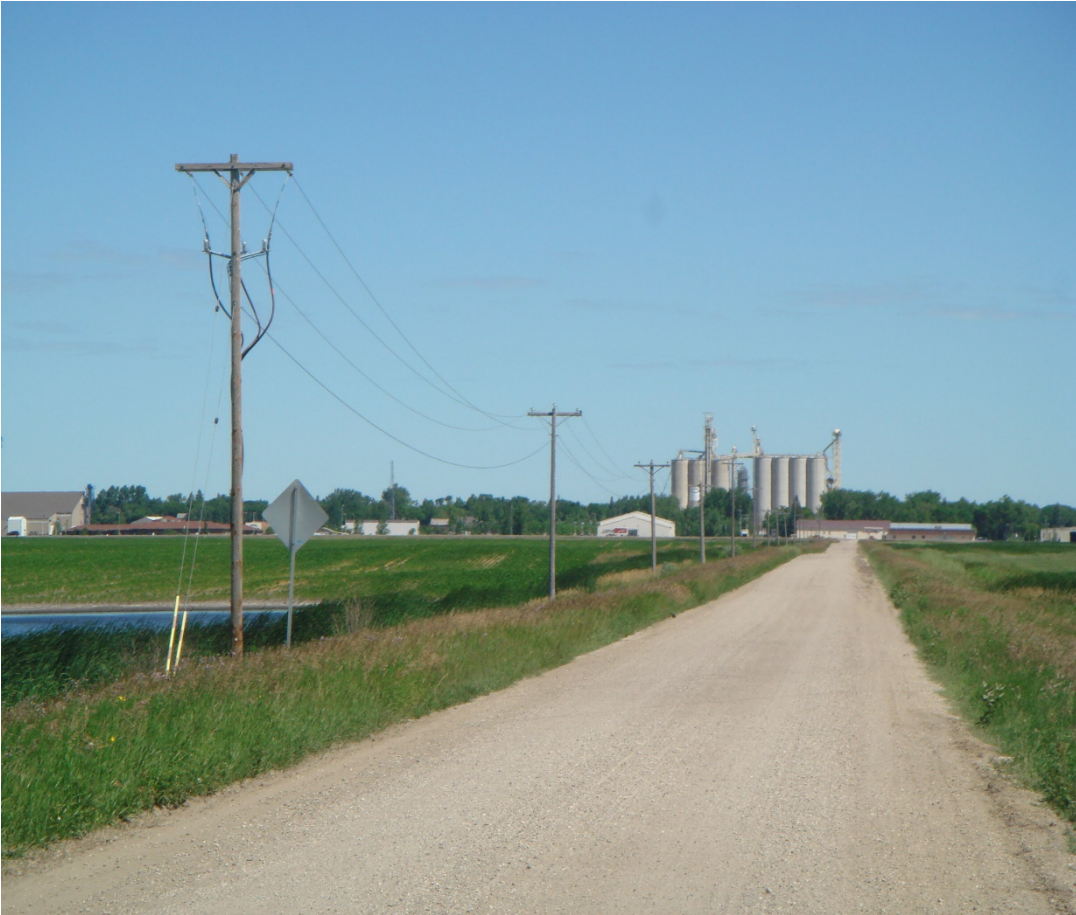
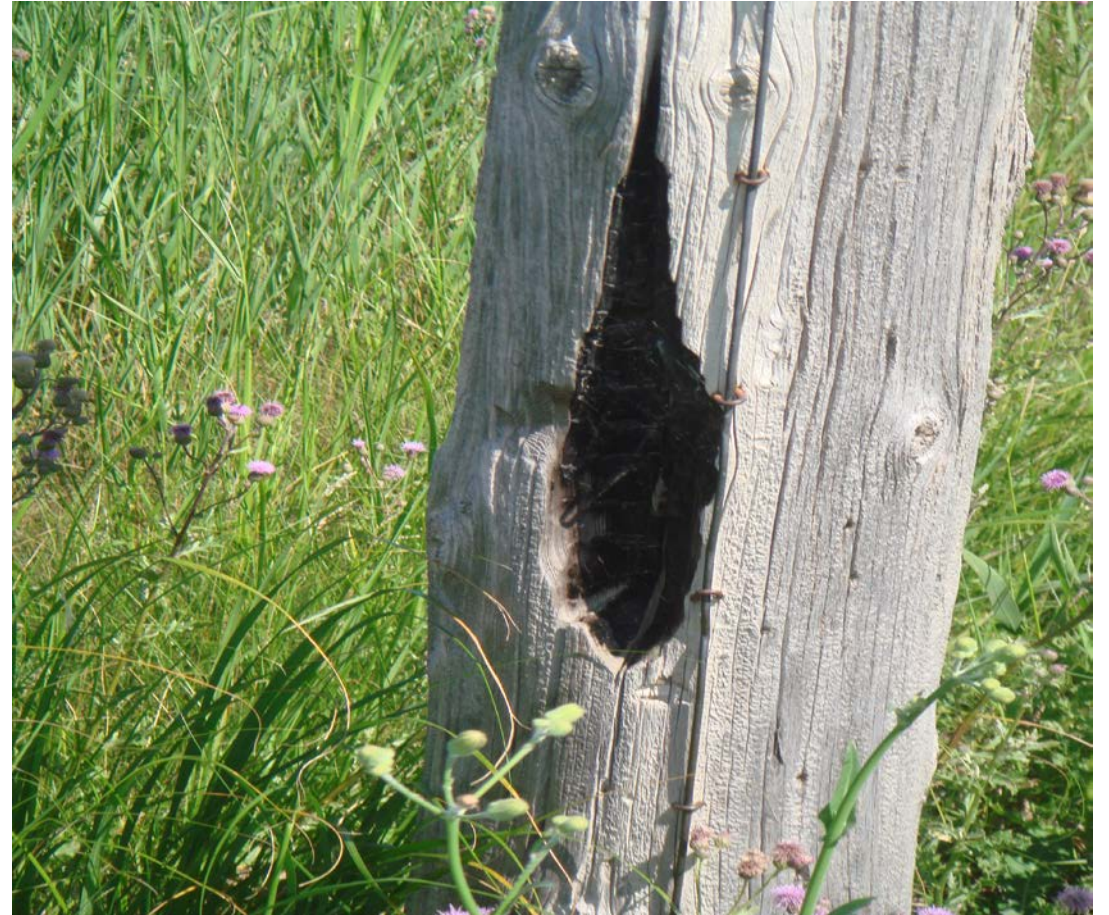
Alternate Feed from WAPA

- Poles in need of inspection and some in need of repair.
- Needs to be completed prior to work being planned by WAPA.

- a. Alternate distribution line (emergency feed) – There appear to be significant issues with the facility. Specifically, there are poles that are in need of repair, cross arms are twisted. MRES considers this the *Highest Priority*.

1. Distribution lines from WAPA substation
 - a. Alternate distribution line (emergency feed) – *Highest Priority* – MRES recommends you engage a distribution engineering firm to evaluate this facility. The review of this facility and repair will need to be completed prior to WAPA commencing work at the WAPA Lakota Substation in 2022 timeframe. Depending on recommendations from the engineering firm, MRES may be able to assist.

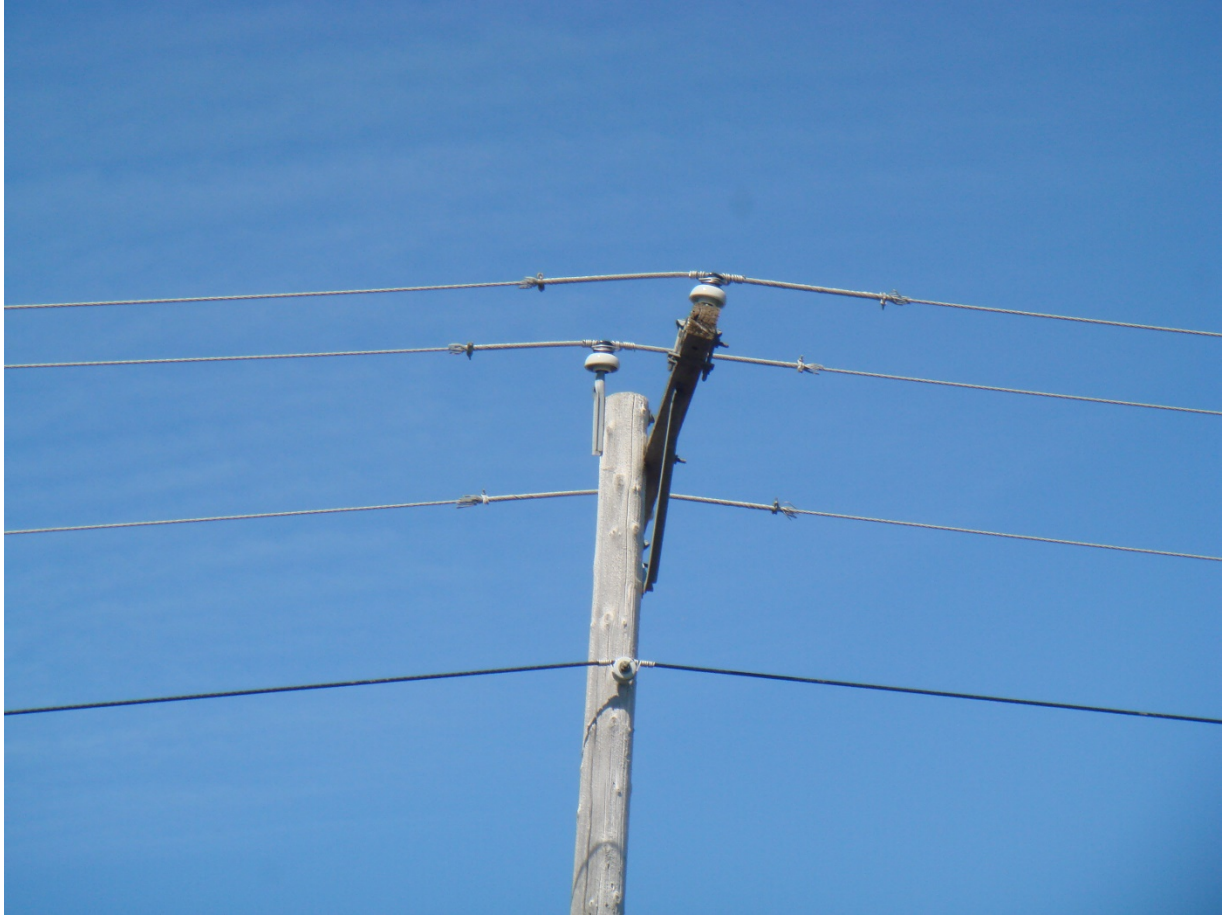
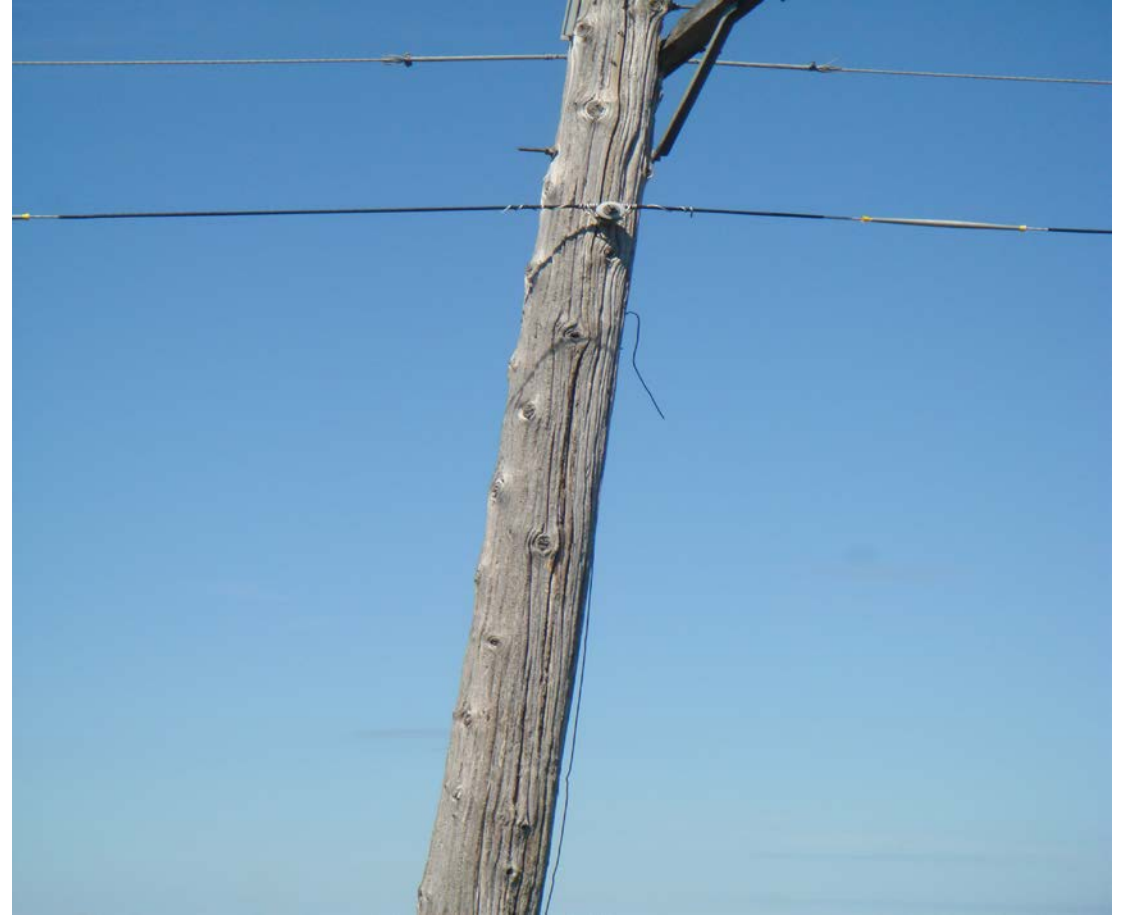
Alternate Feed from WAPA

- Cross arms twisted, causes undo stress and increases failure risk.
- Neutral splice too close to pole, prone to failure.

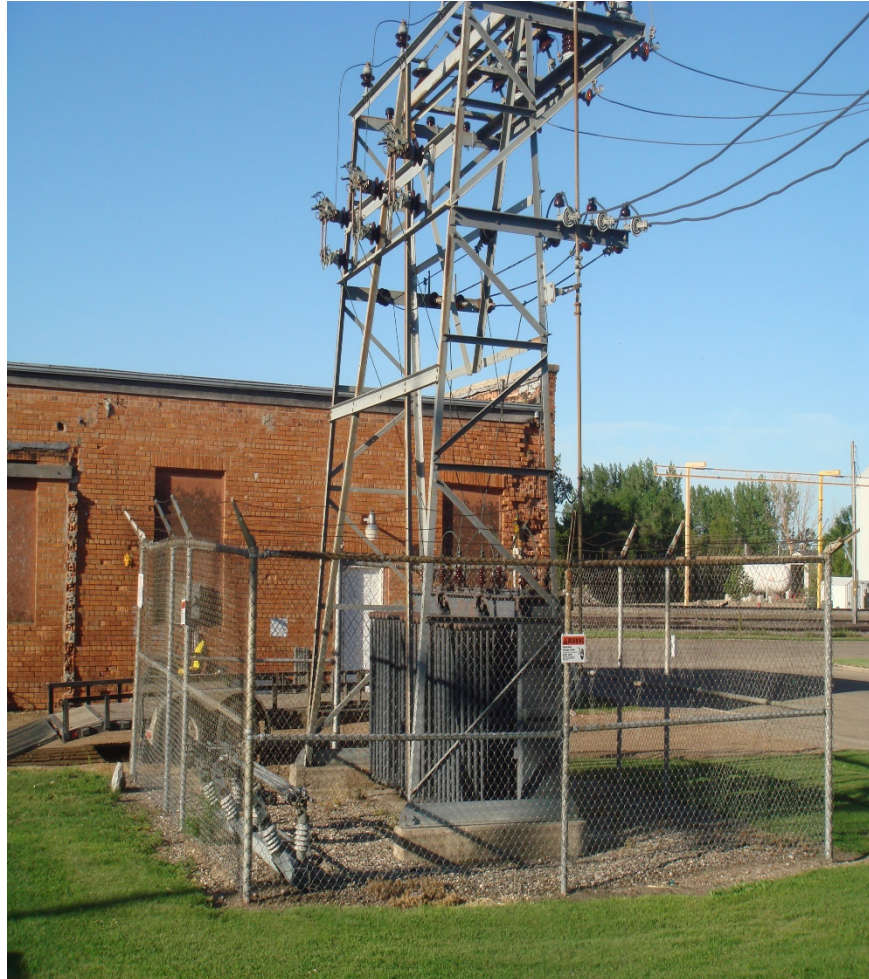
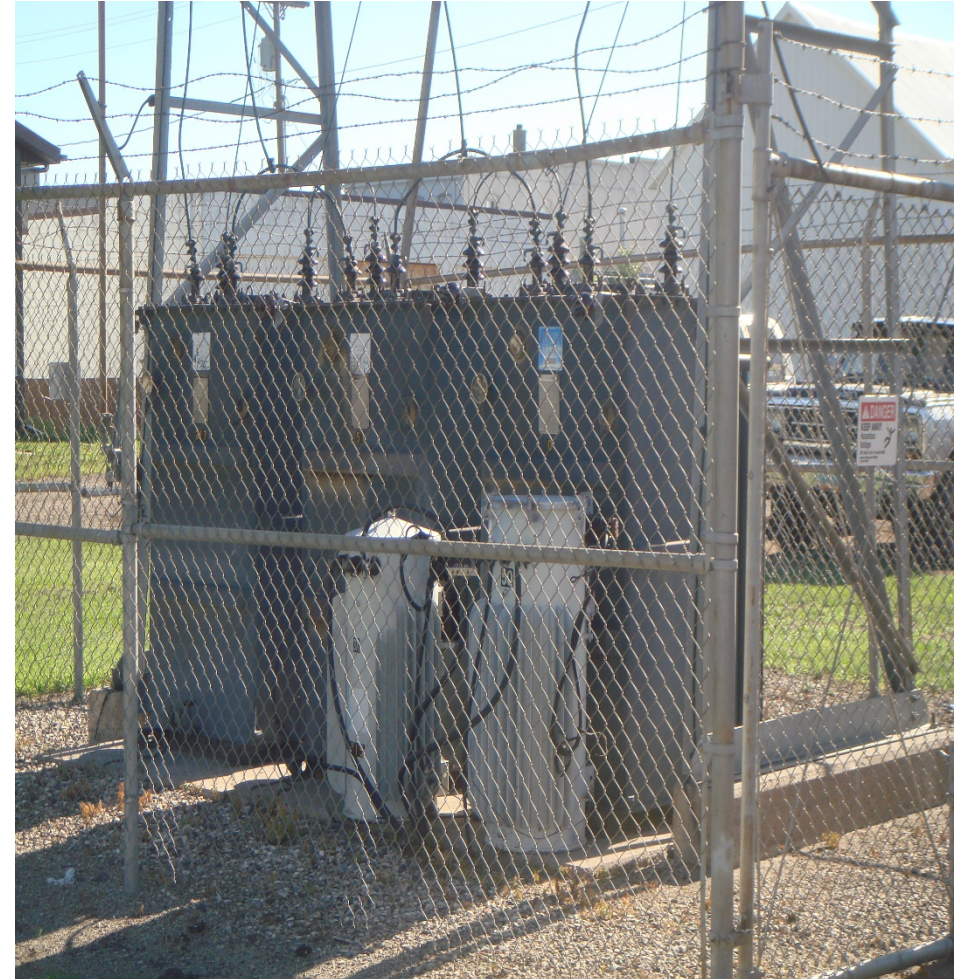
7200 Volt Y to 2400 volt Delta Substation

- The fence around this equipment needs to be moved farther out from the equipment for public safety along with better signage warning public to stay away from area.
- NESC Requirements

Section 110 A for Substations: " A safety sign shall be displayed at entrances. For fenced electrical supply stations, a safety sign shall be displayed on each side. Section 411 D on Work Rules and signs: "Permanent warning signs shall be displayed in conspicuous places at all entrances to electric supply stations, substations, and other enclosed walk-in areas containing exposed current-carrying parts.

2. Lakota 7200V Y to 2400V delta substation in town – Fence is too close to energized equipment and is a public safety concern. If the plans are to finish converting the town to 12470/7200 volt this will eliminate the problem altogether, but that may take time as budget permits work to be completed. MRES considers this a *High Priority*.

2. Lakota 7200V Y to 2400V delta substation in town – Engage distribution engineering firm to determine if voltage conversion or fence mitigation is preferred alternative. MRES can assist with review and analysis of study work, if desired.

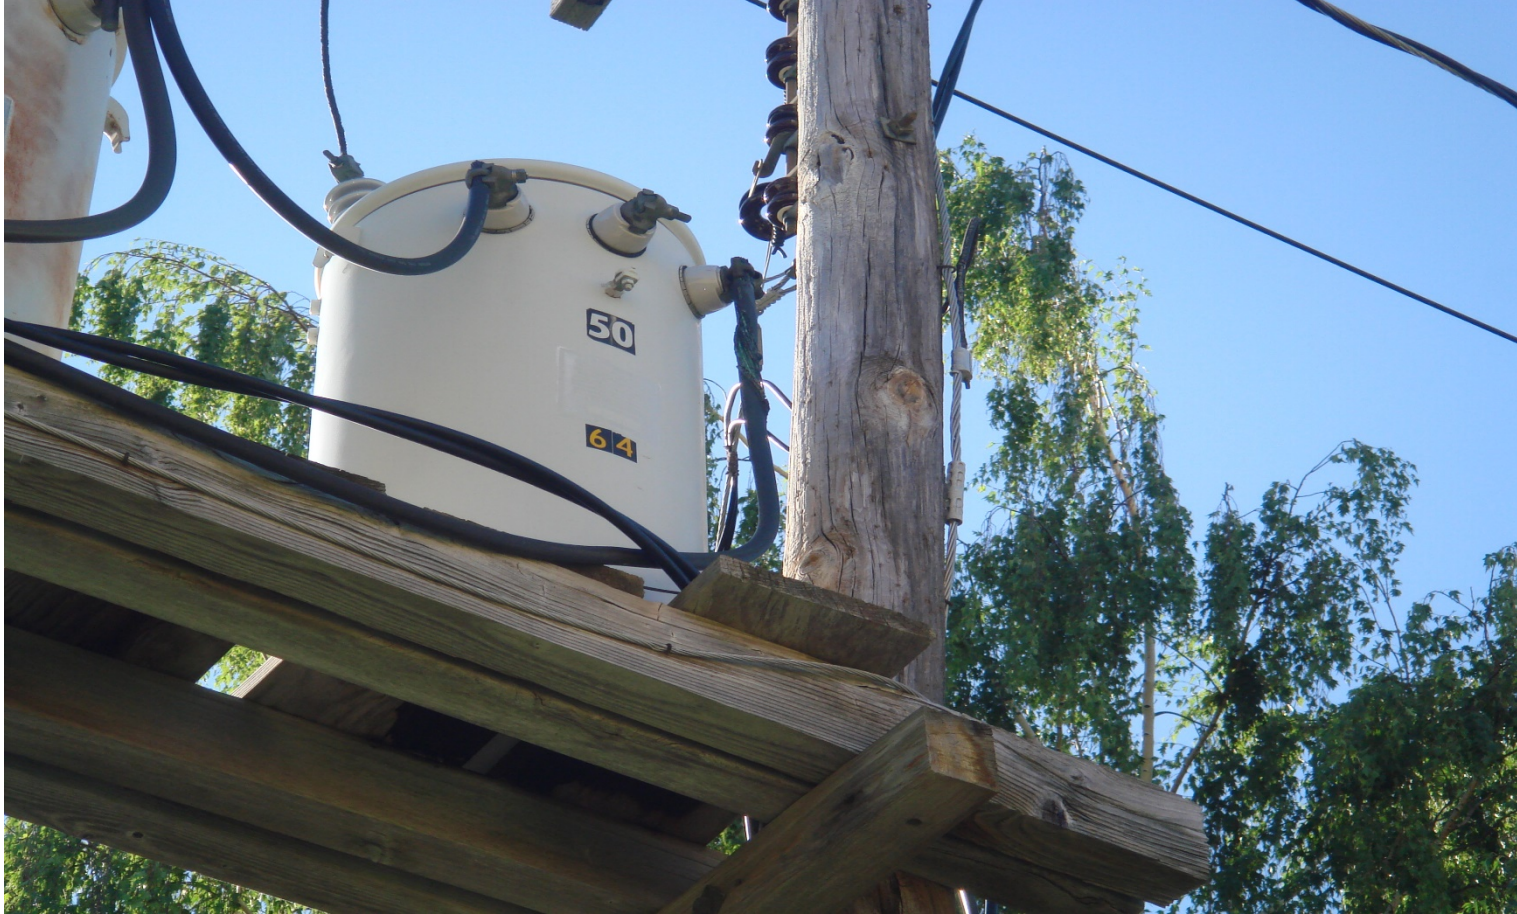
High School Transformer Problem

- Overheated secondary wire at High School transformer bank
- City Crews were informed of the problem before leaving town.

3. High school pole mounted transformers – There is a hot secondary phase feeding the high school. Staff was informed of the issue prior to leaving town. *MRES considers this a High Priority*.

3. High school pole mounted transformers – *High Priority* – Repair overheating secondary feeding high school with local staff.
4. Fire hall alley exposed secondary – *High Priority* – Bury the secondary utilizing local staff.

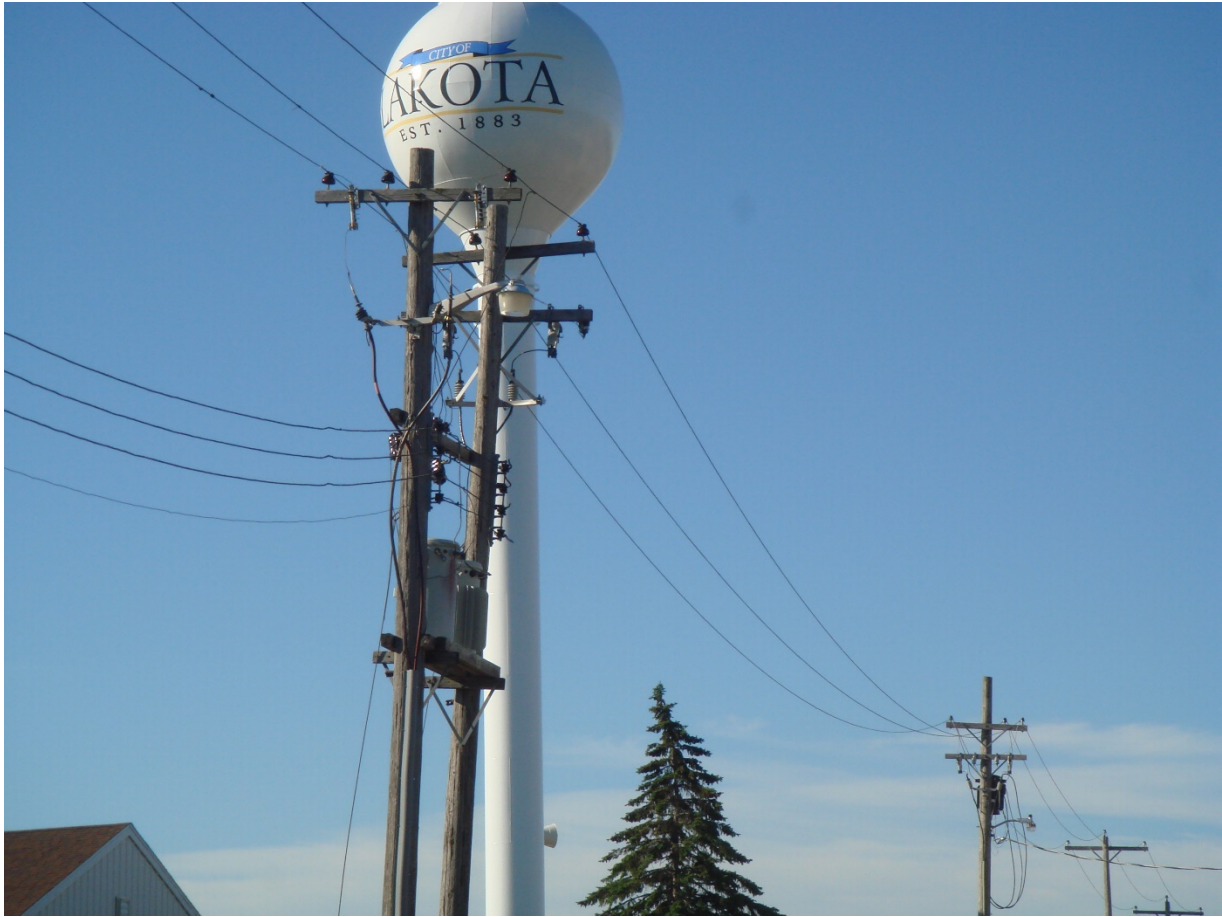
Secondary in Conflict with Primary

- Secondary wire needs to be lower than Primary wire to be worked on safely.
- Safety issue if primary falls into secondary, injecting high voltage into secondary.
- This is a code violation.

5. Secondary wires mounted higher than primary – Numerous areas in the community with secondary wires mounted higher than primary, as this is a safety issue if the primary were to fall onto the secondary wires. MRES considers this a *Priority*.

5. Secondary wires mounted higher than primary – *Priority* – These should be moved to mitigate any future potential safety issues, as staffing/budgeting allows. MRES could perform the task with coordination for materials, timing, etc., if desired, but would likely need to be done over a more extended time period. However, it may be better to work with a contractor to mitigate these over an extended period. If this latter alternative is chosen, MRES could help specify materials needed to complete the given projects.

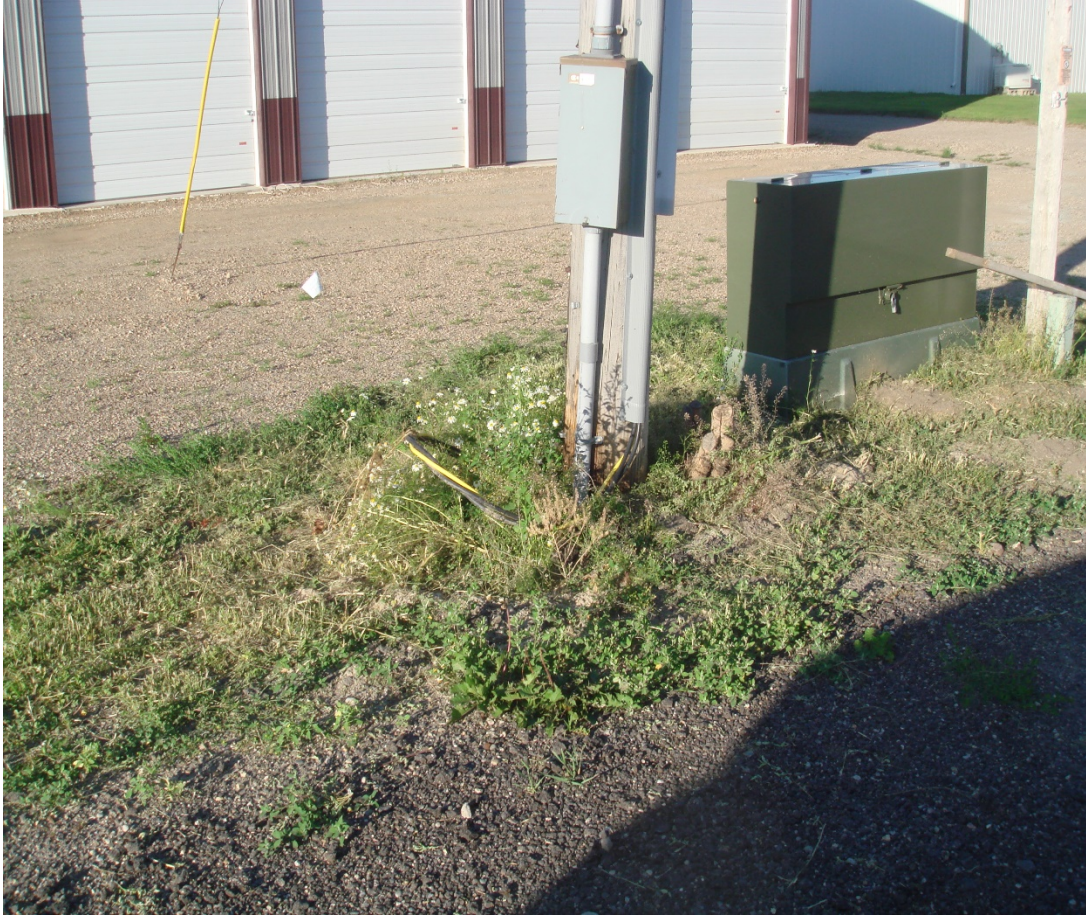
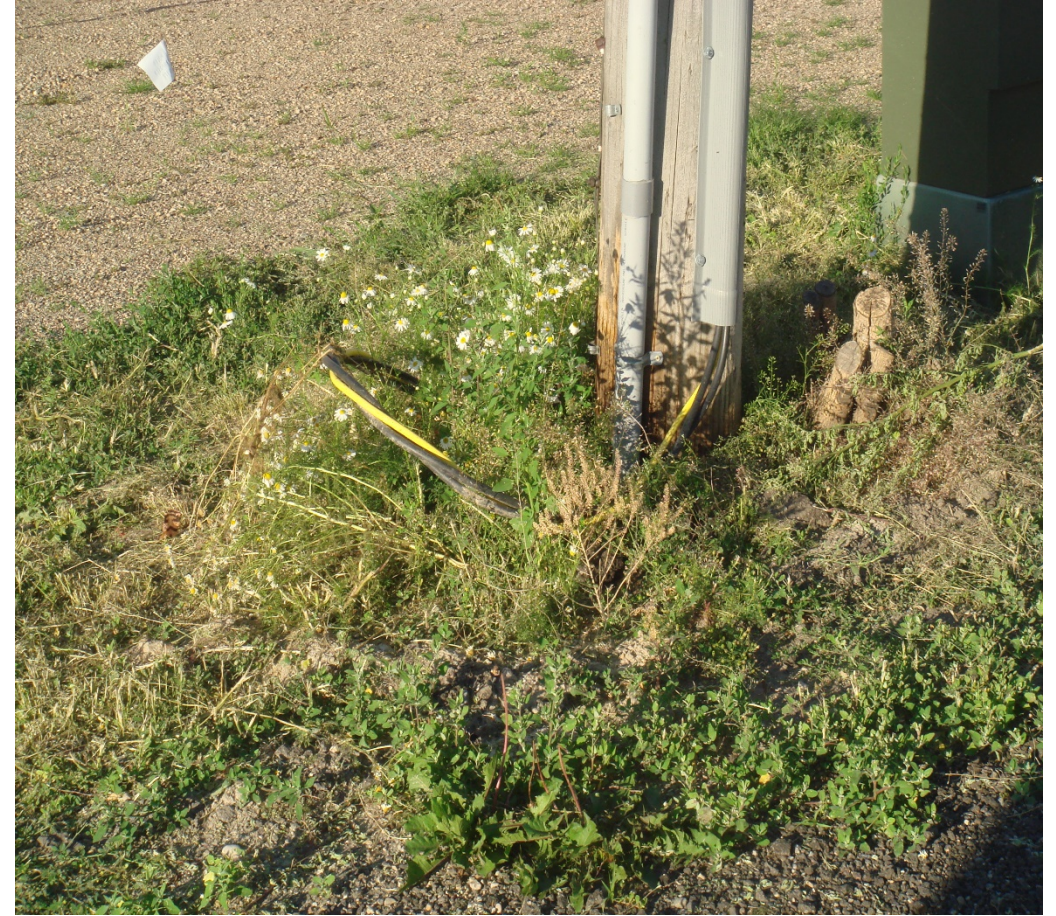
Newer Service Fire Hall Alley

- Secondary service unburied and not protected at base of pole.
- City crew is now aware of the problem, they will finish project before it gets mowed over.

4. Fire hall alley exposed secondary – There is an exposed secondary on new construction in fire hall alley. Staff was informed of the issue prior to leaving town. *MRES considers this a High Priority*.

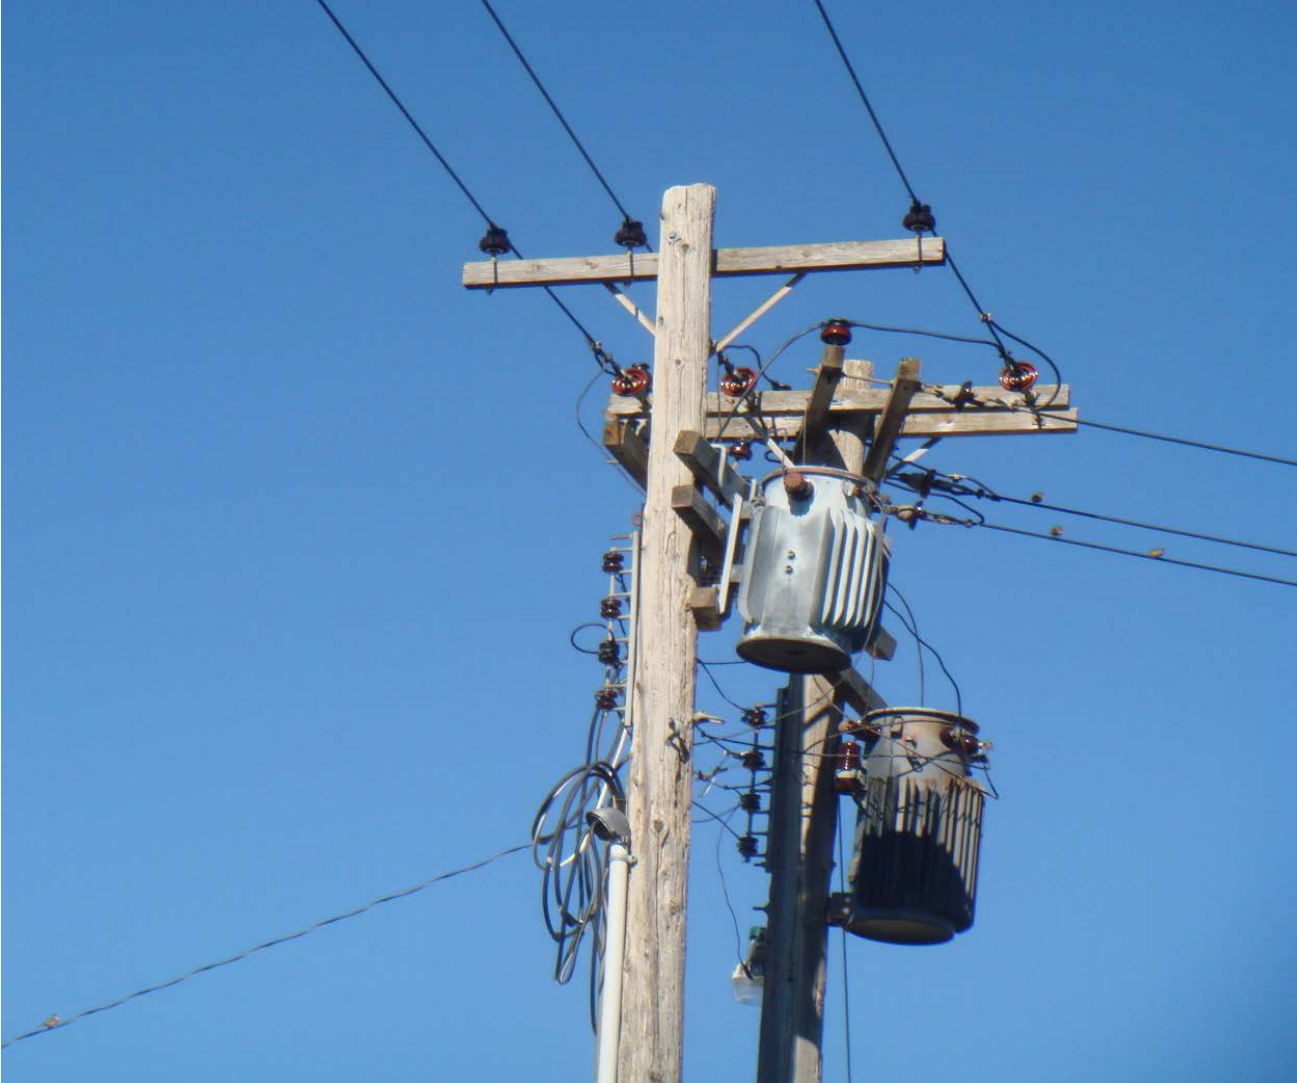
Ave A & 6th West

- Cross arm being pulled off by transformer (arm going bad)

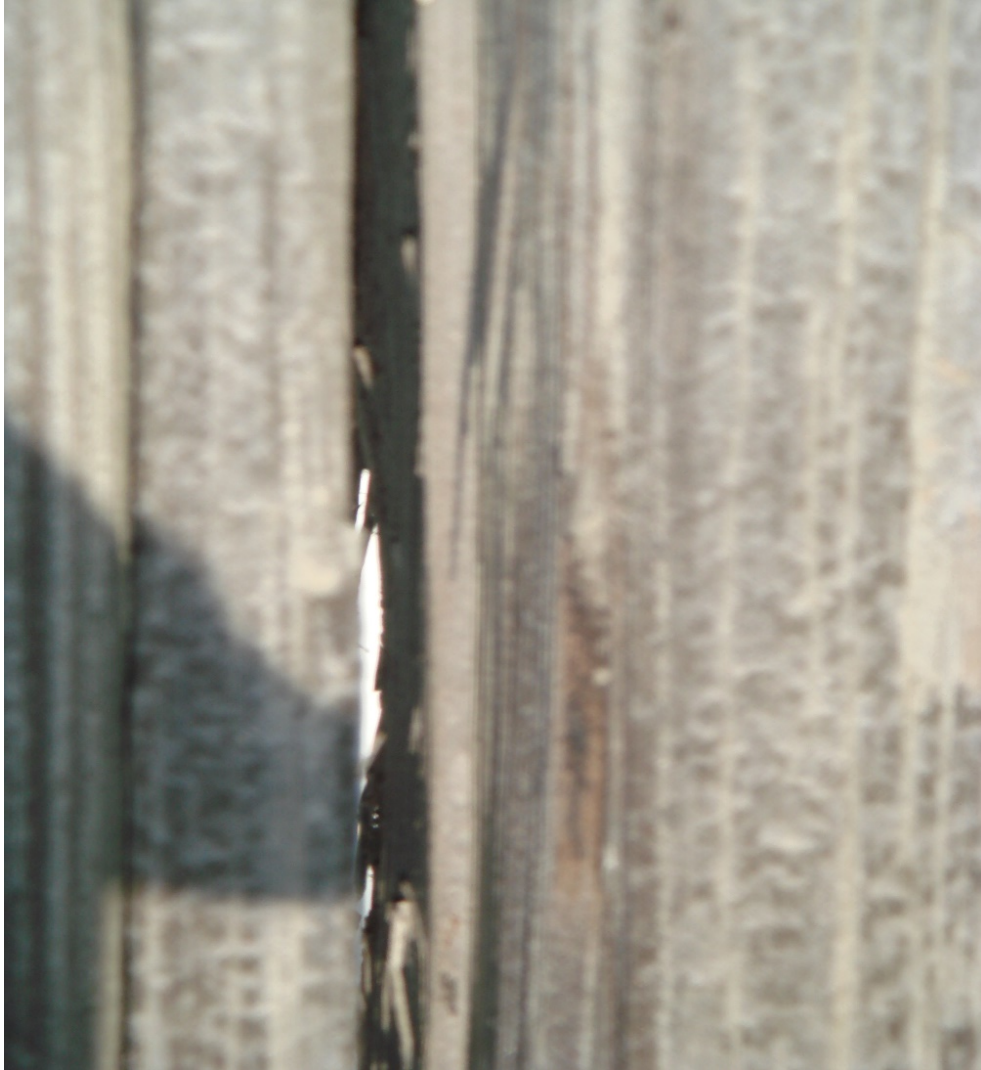
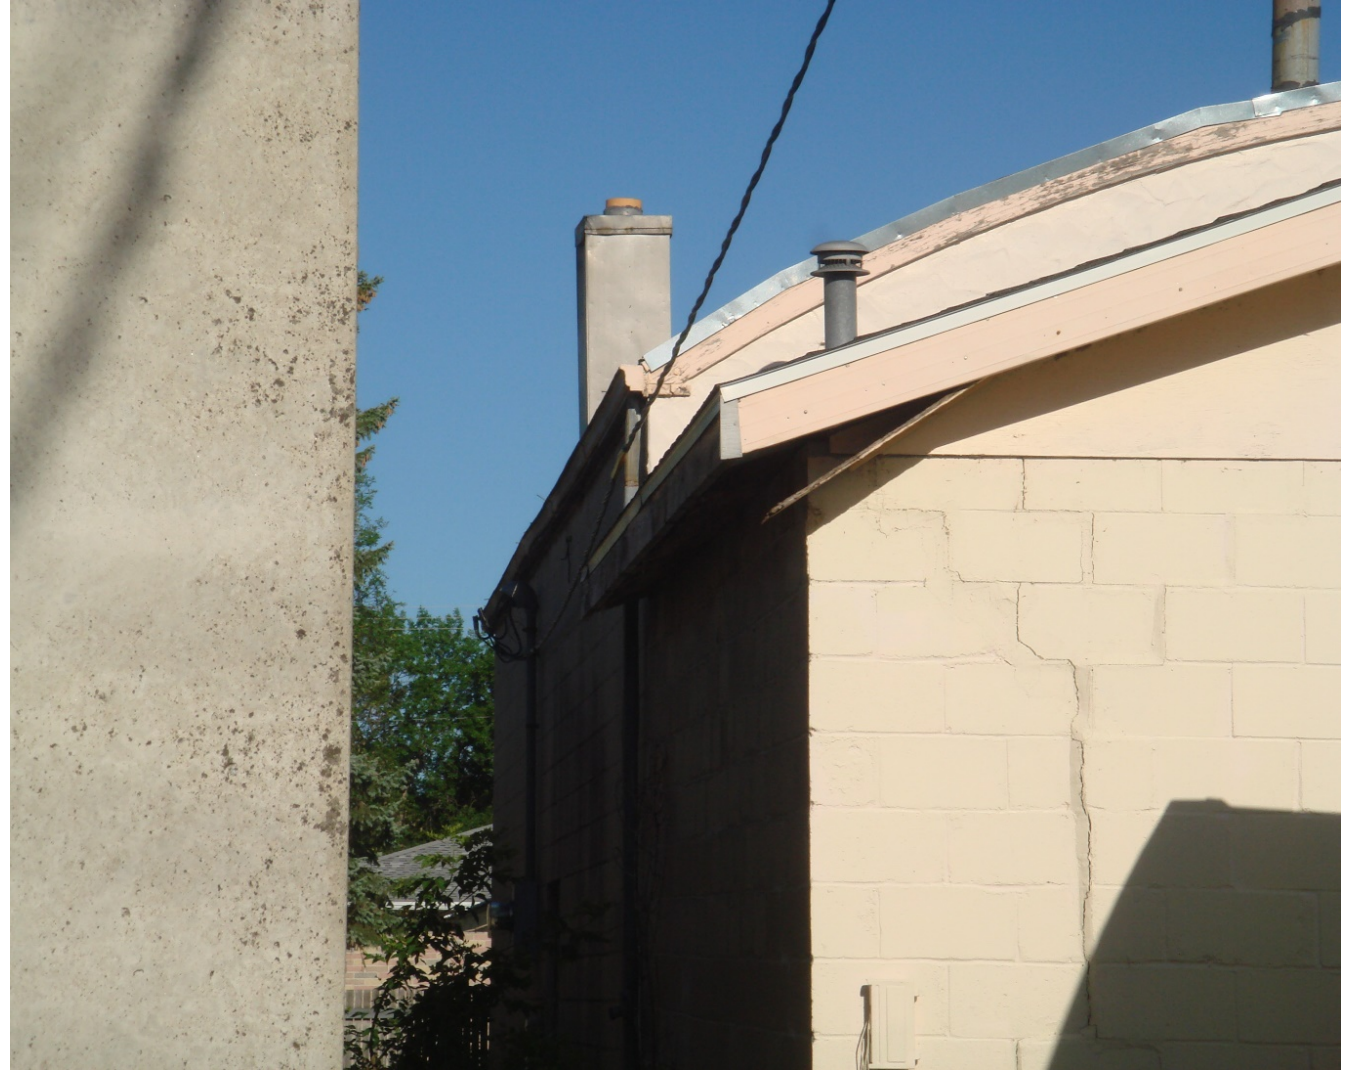
Bad pole behind 218 Main service problem

- Can see through pole to LP tank pole, because it is split dead center
- Service to this customer rubs the side of the building to service entrance
- When replacing pole move it to the south to help eliminate the service problem
- General issue - there are a number of poles within the community that are overdue for replacement and should be worked into budget

6. Overall distribution pole condition – Numerous poles are in need of replacement. MRES considers this a *High Priority* due to the quantity of poles needing replacement.

6. Overall distribution pole condition – *High Priority* – MRES could perform the task with coordination for materials, timing, etc., if desired, but would likely need to be done over a more extended time period. However, it may be better to work with a contractor to mitigate these over an extended period. If this latter alternative is chosen, MRES could help specify materials needed to complete the given projects.

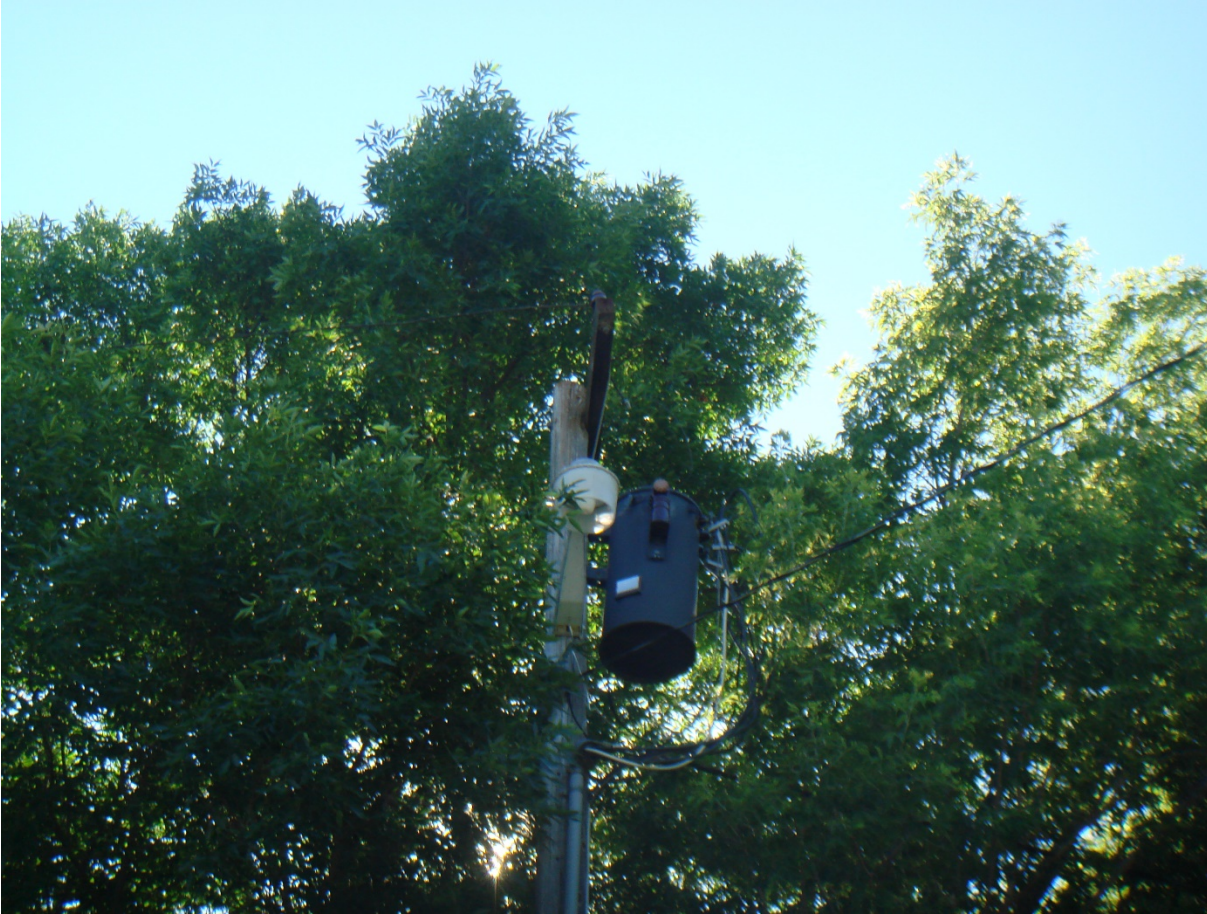
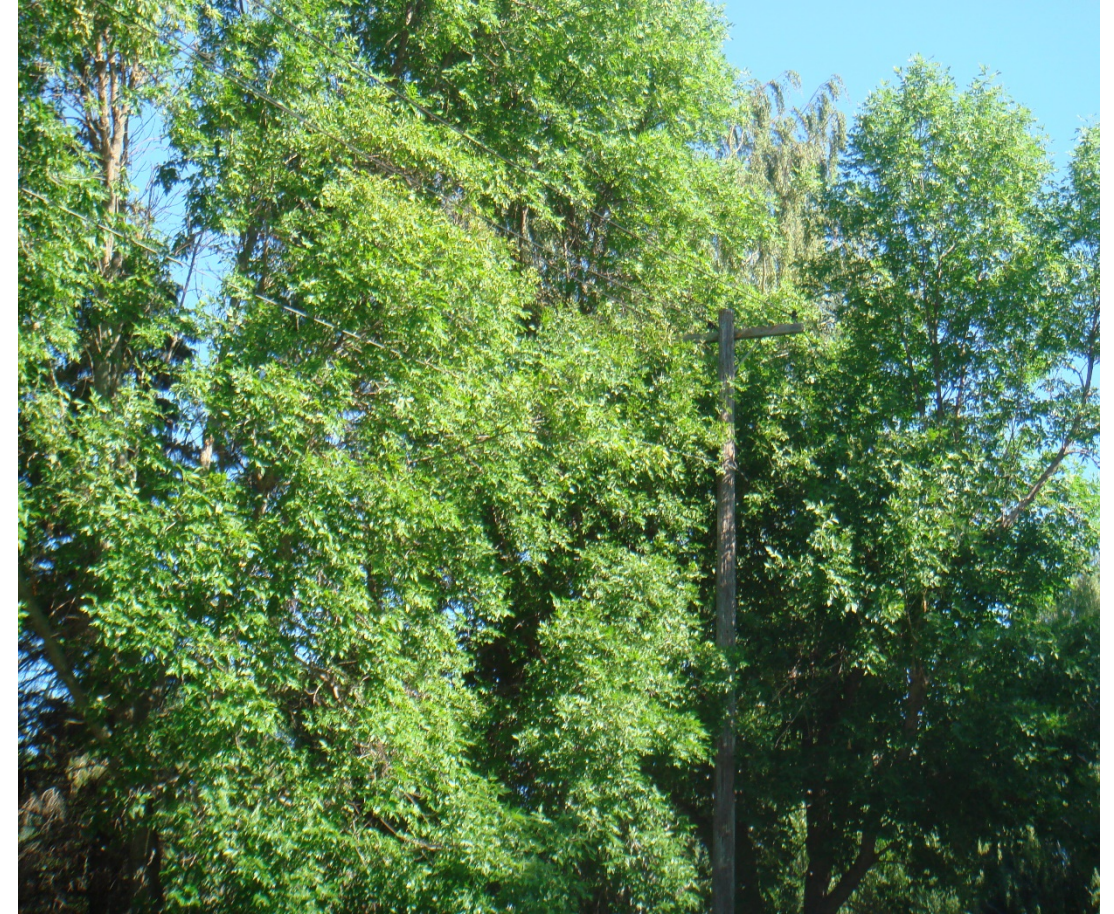
Vegetation Management – Tree Trimming

Some areas look like they are harder to address and need some attention before they start to cause major problems.

7. Tree trimming – MRES considers this a *Priority*.
8. General items;

7. Tree trimming – *Priority* – Numerous areas in the community require tree trimming. These could be performed with local crews using a properly equipped truck.

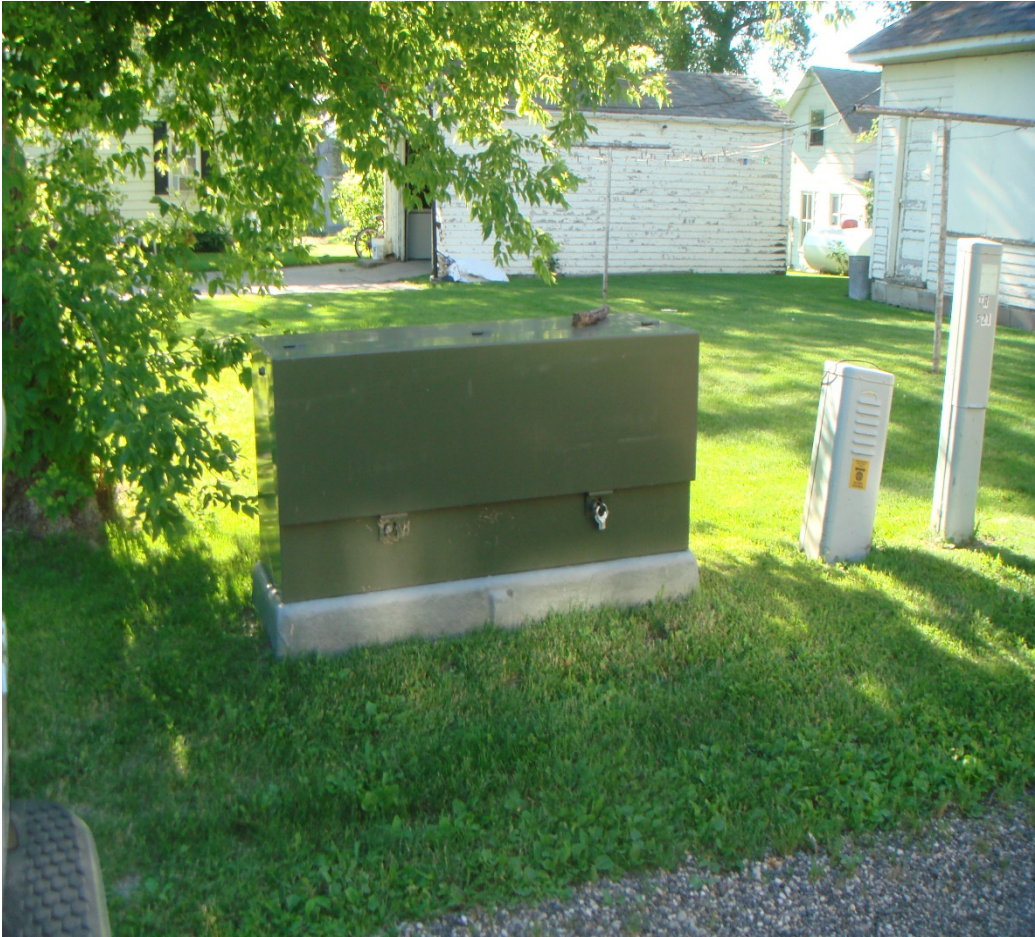
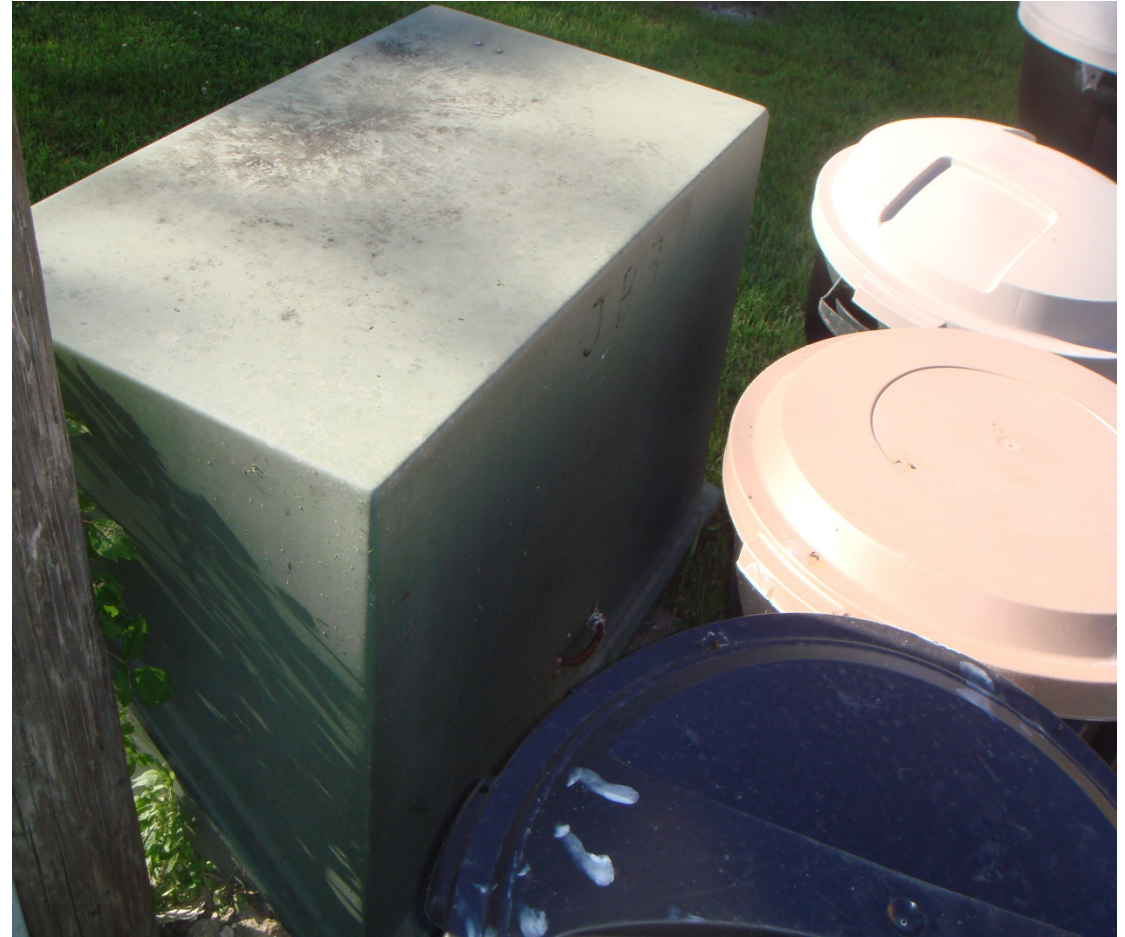
Underground system warning labels

- WARNING labels should be used on the outside of transformer enclosures, substations
- DANGER signs and labels for the inside of a transformer, for equipment on the inside of a substation and for towers. See appendix B of the NESC handbook.

- a. Safety warning/labels – There were few safety warning labels on equipment as required by NESC. MRES considers this a *Priority*.
- b. Material – Based on our high level review, it appears the community has adequate material for normal operations and maintenance.
- c. Major equipment – Digger Derrick – This is a critical piece of equipment and is needed for almost any basic maintenance work. MRES considers this a *High Priority*.
- d. Staffing – MRES suggests the community further evaluate how to approach maintenance of the distribution system long-term going forward. To ensure reliability of the distribution system going forward, proactive distribution maintenance is needed. MRES considers this a *High Priority*.

8. General items;
 - a. Safety warning labels – *Priority* – These should be installed by local staff.
 - b. Material – Continue to monitor to ensure adequate material is available for routine maintenance.

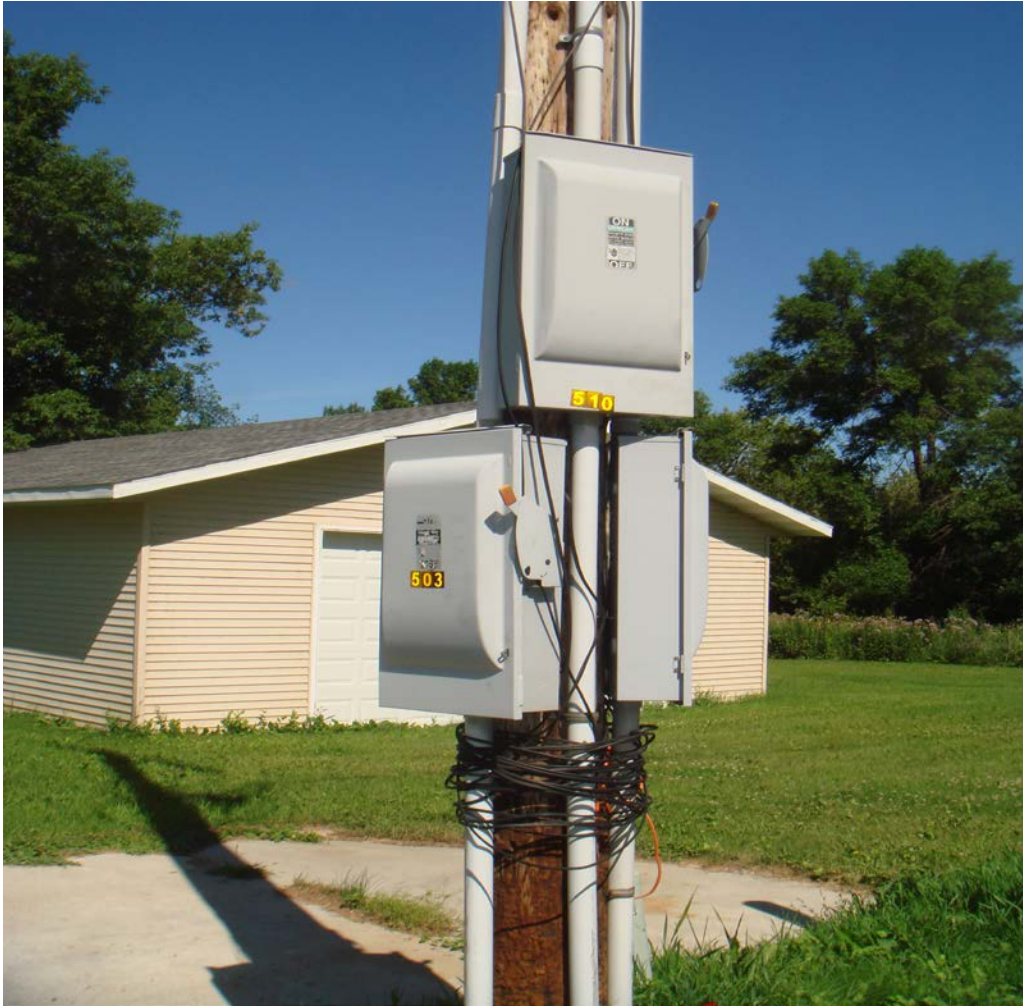
Secondary disconnects on poles

- **NESC Regulation 236** NESC regulation 236 states that climbing space around poles must be an unobstructed vertical space.
- Would recommend a secondary pedestal placed near the base of the pole with one triplex conductor on the pole feeding the pedestal and services feed out of the pedestal.
