### Outdoor Heritage Fund Status and Final Report Form/Guidelines

Contract Number <b>005-083</b>	Report Date <b>8/31/2016</b>	Period Covered by Report <b>4/1/2016 to 8/31/2016</b>
-----------------------------------	---------------------------------	--

Project Name  
**The Fargo Project: World Garden Commons**

Project Sponsor Name  
**City of Fargo**

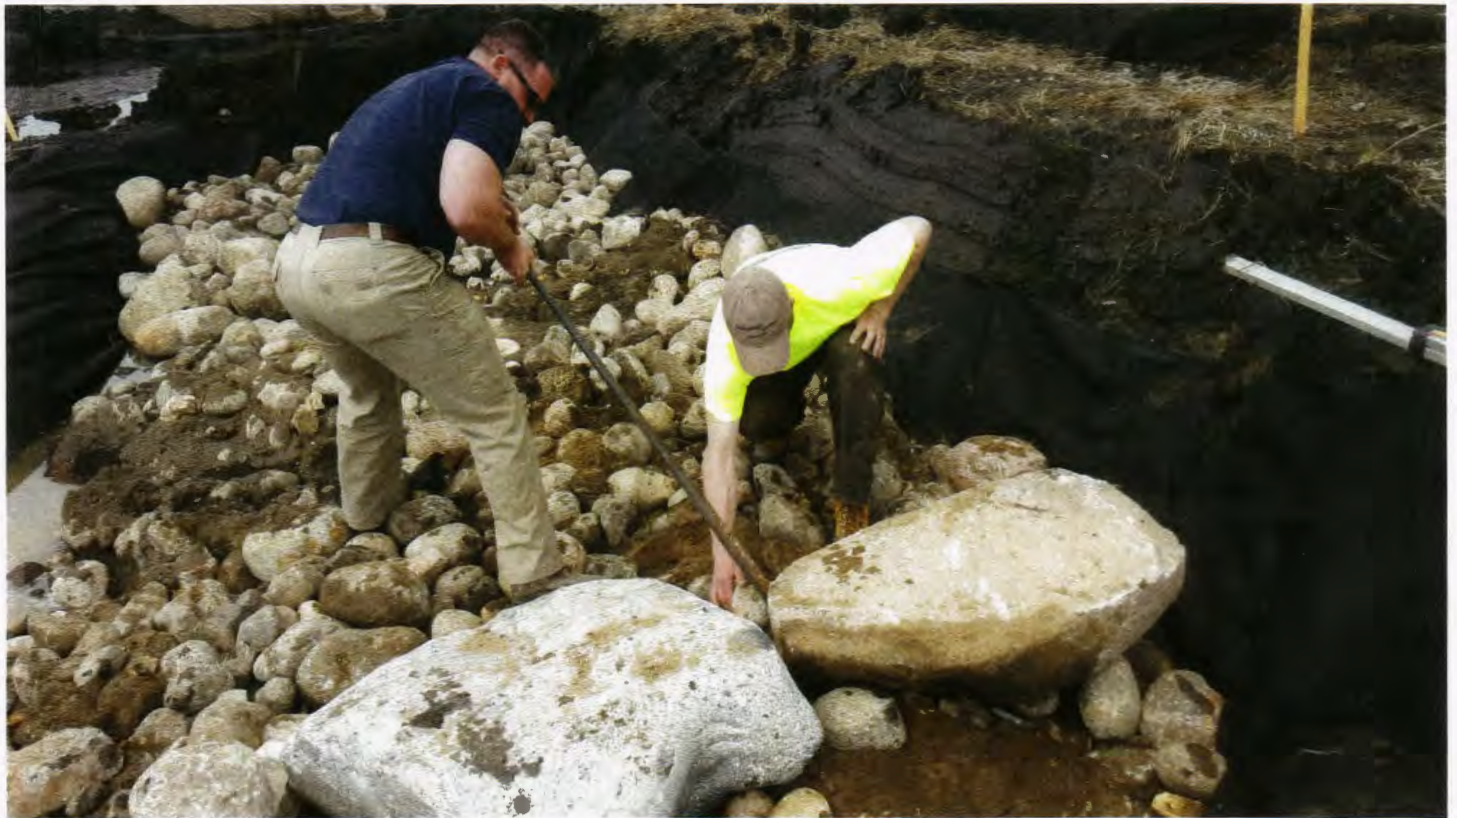
Construction of Rock Vane (April 2016)

Last fall and winter, a portion of the channel was eroding. A rock vane was anticipated to be constructed last winter on frozen ground, however, warmer temperatures did not allow. In the spring, it was found that the channel had eroded more than previously thought. Due to the adaptive management focus of the project, we reevaluated the location and restoration techniques. The rock vane was installed mid-April and is functioning as anticipated.

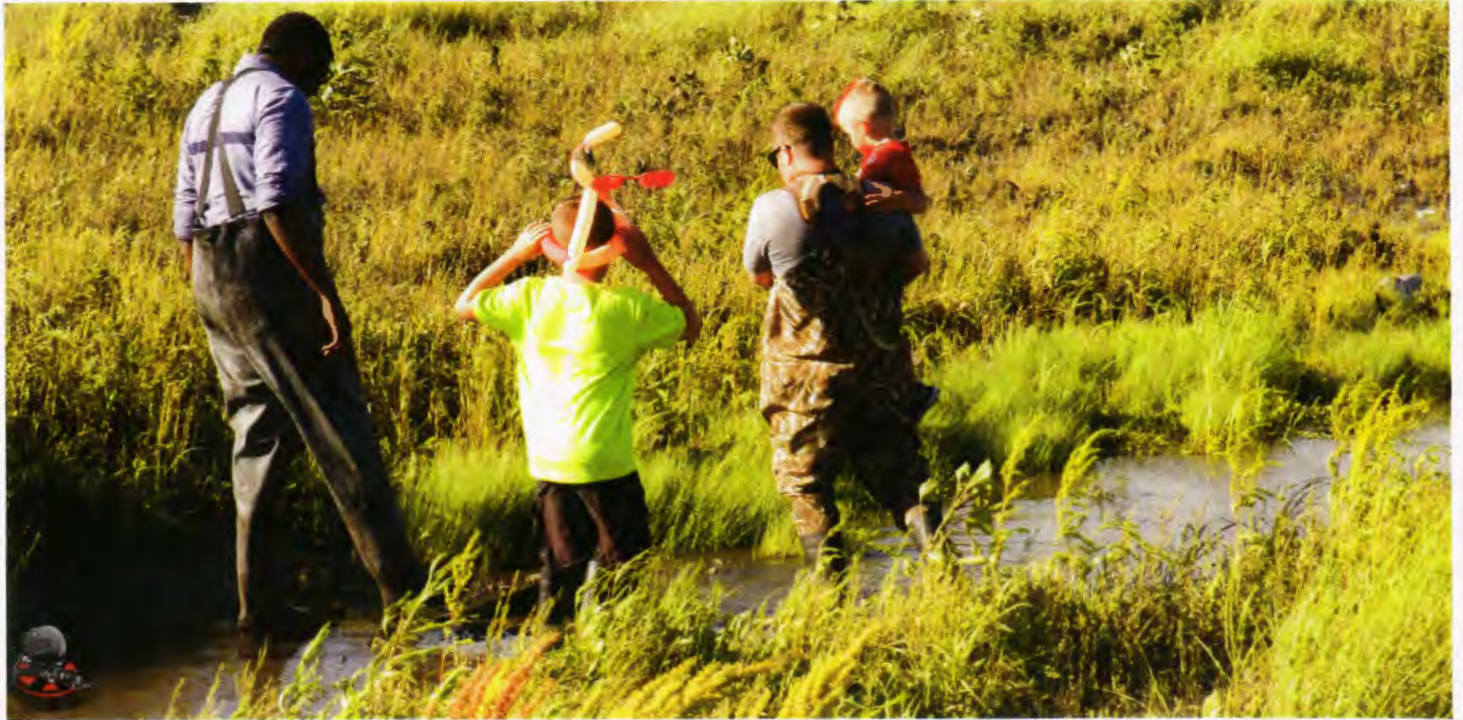
Site & vegetation restoration of area of concrete channel removal (July 2016)

We anticipated the full removal of the concrete channel in 2016. However, with reconstruction of the inlets and outlet, and with the equipment needed for demolition and earthmoving, the remaining concrete will stay in place for access with the anticipation it will be removed by Spring 2017.

Site restoration (seeding, plantings, vegetation establishment) continues on the site. We are finding that in the undisturbed areas, the site has many native species, and we continue to take steps to encourage that growth while managing invasive species. The restoration methods on areas of disturbance require more intensive restoration, however, we plan to seed and plant as much as possible to encourage establishment.
