North Dakota Transmission
Authority

Overhead to Underground

City of Lakota/Lakota Municipal Utilities

Summary of MRES Assessment for Lakota Distribution System

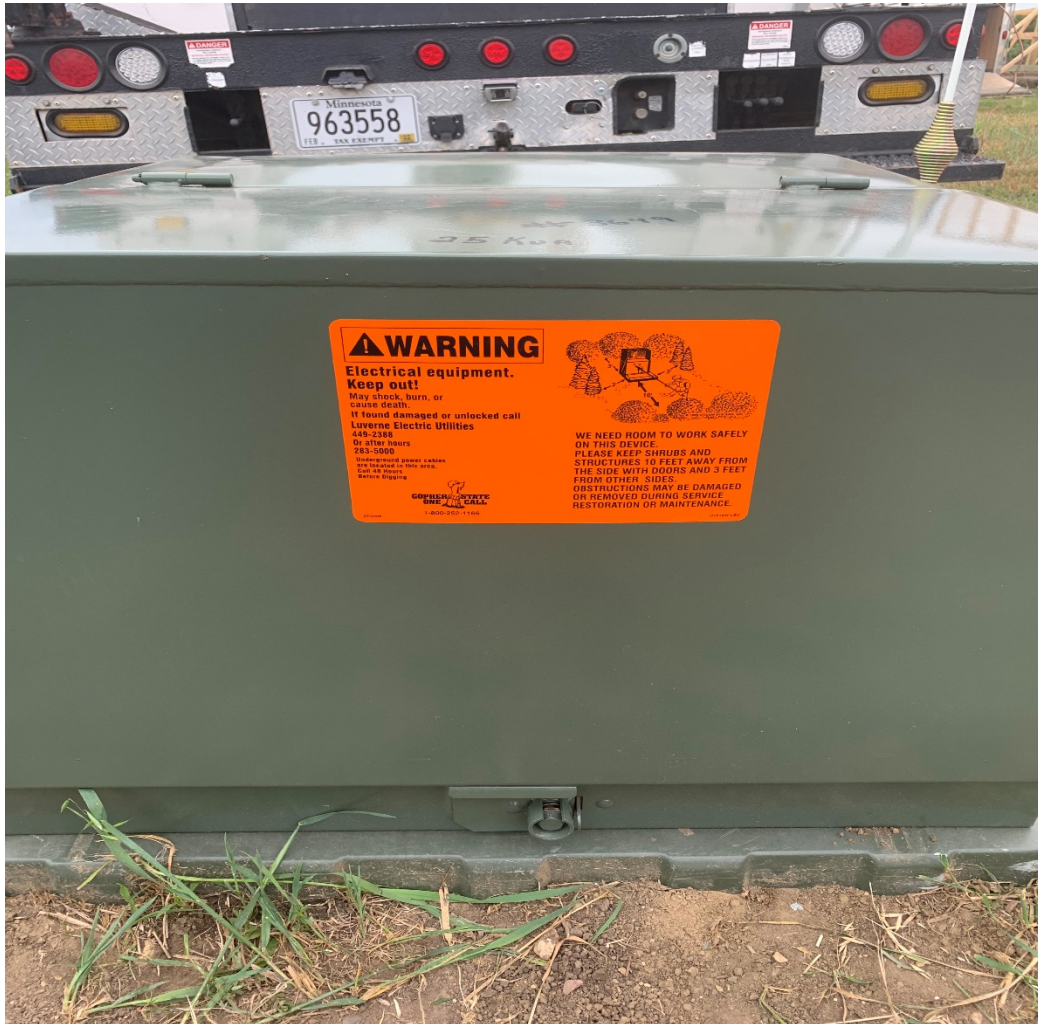
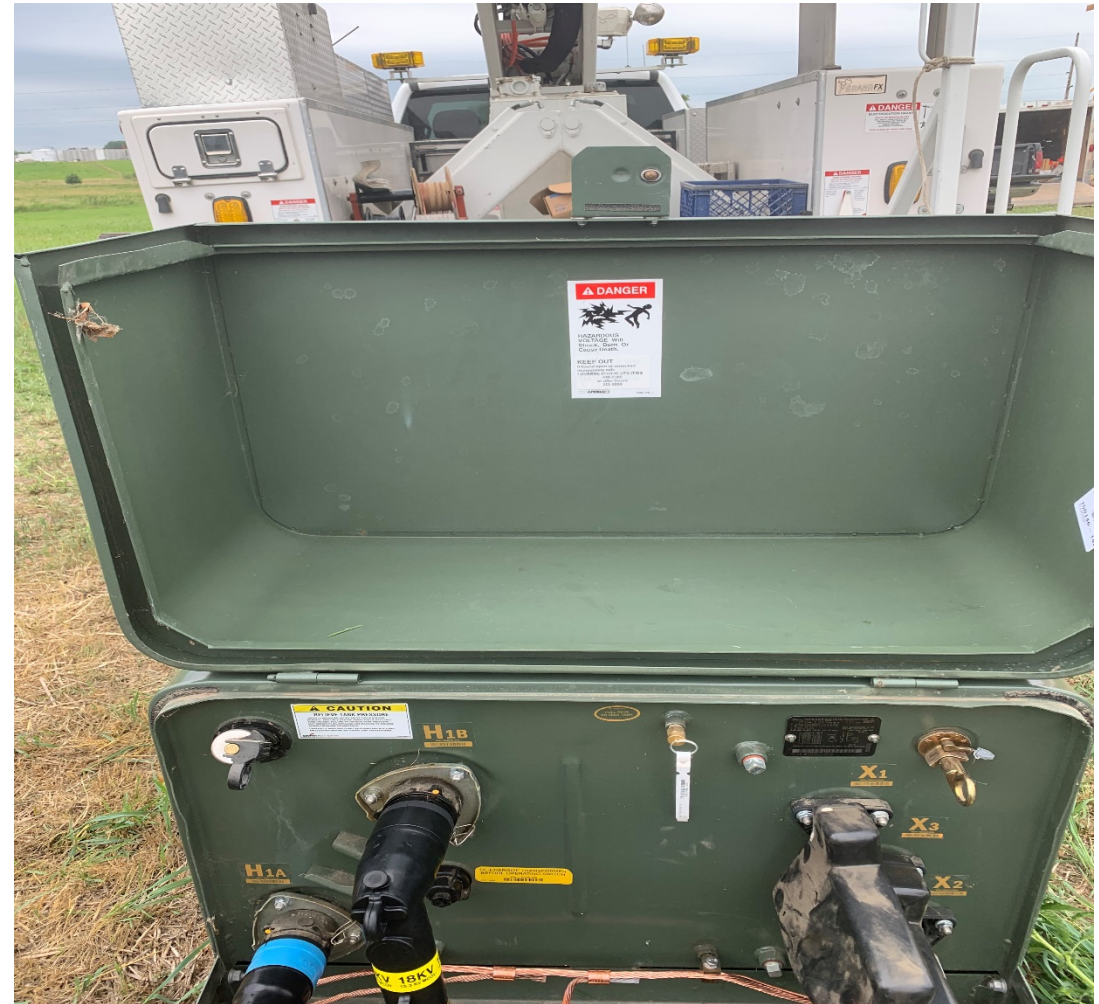
Proper Labeling

- WARNING labels should be used on the outside of transformer enclosures, substations
- DANGER signs and labels for the inside of a transformer, for equipment on the inside of a substation and for towers. See appendix B of the NESC handbook.
