**Outdoor Heritage Fund
Status and Final Report Form/Guidelines**

Project Name
LaMoure County Dam Reparation Project

Project Sponsor Name
LaMoure County Water Resource District

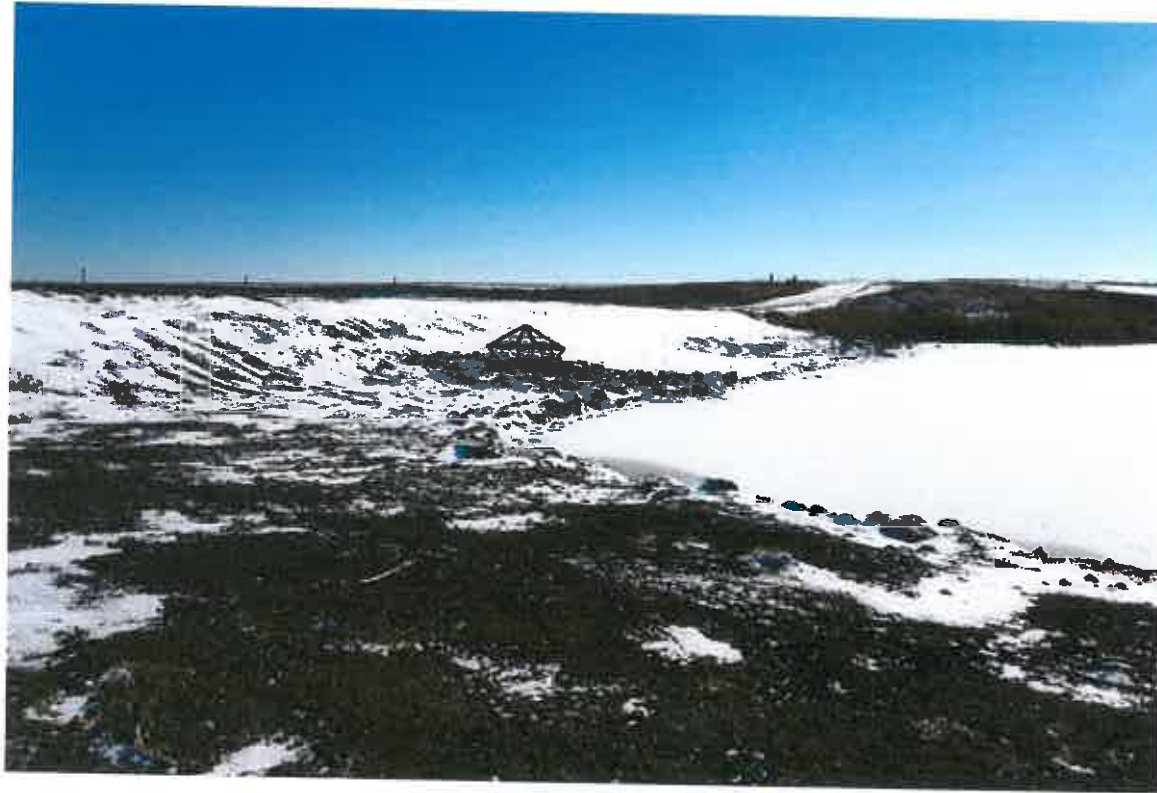
Schlecht Thom Dam

Water levels at all three of these impoundments were lowered to facilitate repairs. Cofferdams were constructed on Schlenker and Schlecht-Thom dams so that aging and badly rusted corrugated metal piping serving as risers could be encapsulated in concrete whereby sealing existing leaks and preventing the formation of additional holes. Similar repairs occurred at Kulm-Edgeley though the situation here was slightly different. The vertical outlet structure was separating from the horizontal outlet pipe through the dam allowing varying degrees of flow (including existing fill around the structure itself) to uncontrollably leak.

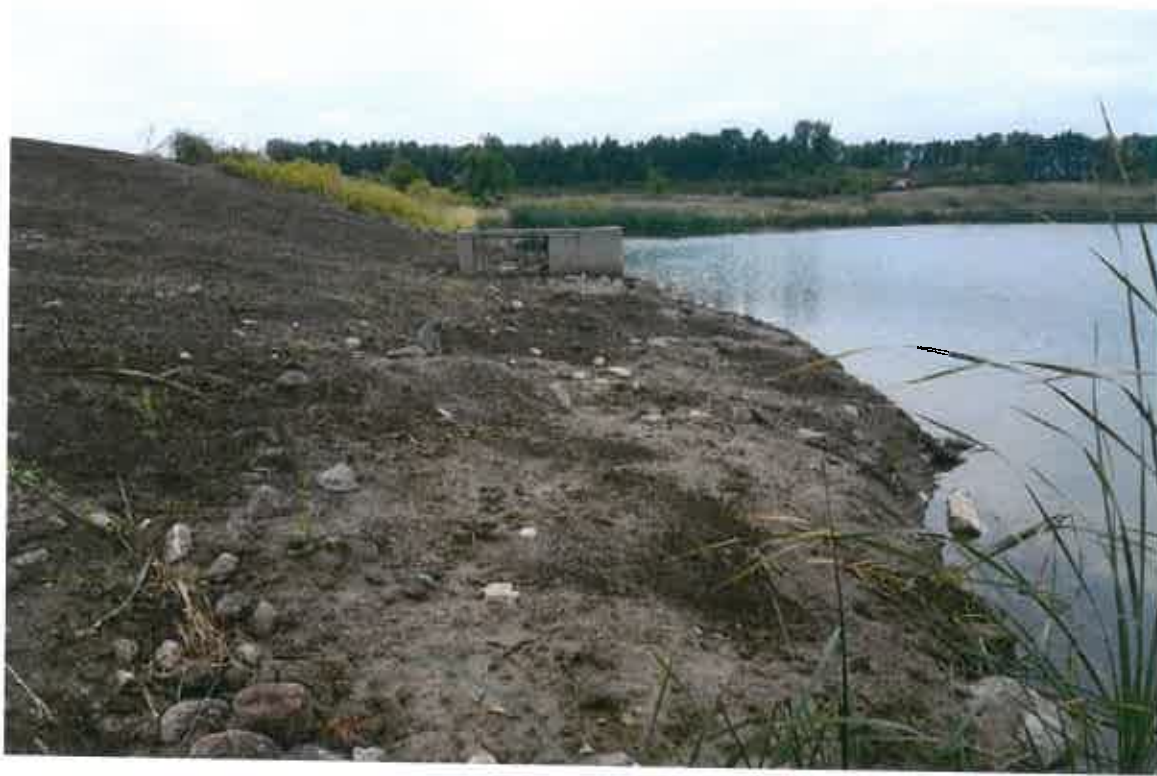
Kulem Edgeley Dam

Critical reparations have been completed by the State Water Commission on three LaMoure County dams. The water control structures on Kulm-Edgeley, Schlenker, and Schlecht-Thom were all leaking in varying degrees threatening established fisheries, hampering water quality improvement efforts, and negatively effecting recreational opportunities at public use areas.
